THE UNITED STATES
STRATEGIC BOMBING SURVEY

THE EFFECTS
OF
THE ATOMIC BOMB
ON
HIROSHIMA, JAPAN

Volume III

Physical Damage Division

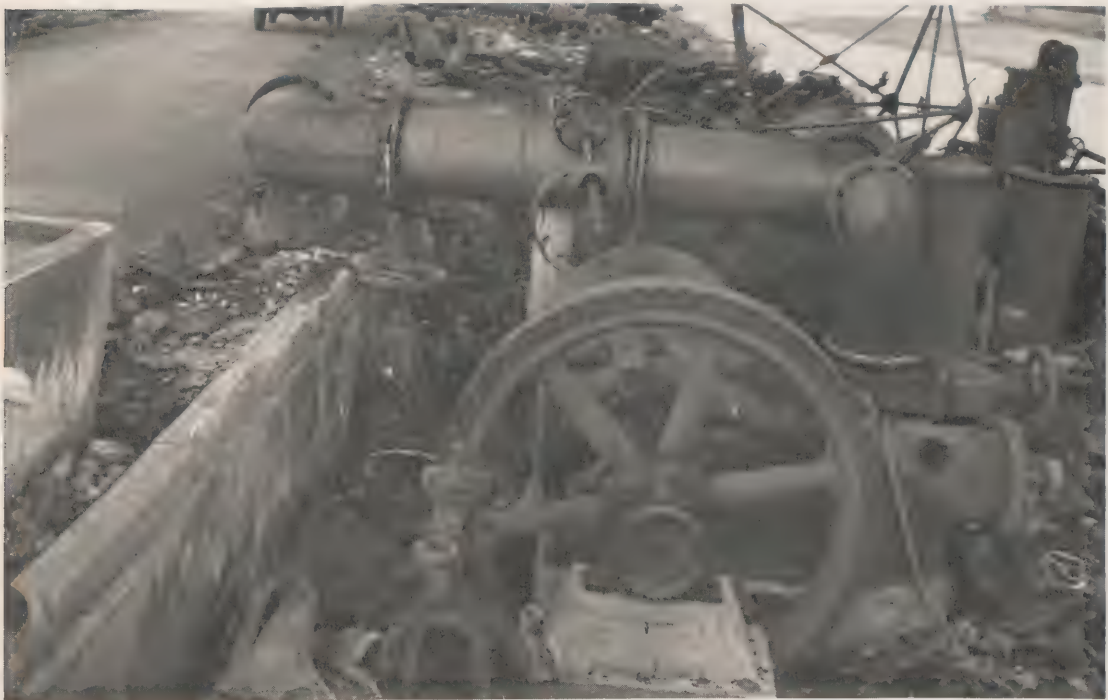
b. It will be noted that the electric-motor damage of Stations 1 (Photo 135) and 5 is classified as heavy, the cause being that plaster and debris fell in the motor rotors while in operation, resulting in a severe short circuit and burning of the coils. Stations 12 (Photo 136) and 13, damaged by blast, suffered small-panel and incidental-equipment damage, insufficient to prevent operations. Since Station 12 was under construction and all equipment was not installed, however, it was not considered as being in operative condition. The equipment in the four electrically operated stations (6, 7, 10, and 14) which were damaged by fire (Photos 137, 138, and 139) was rendered totally useless as was that in gas-fuel-operated Station 9 (Photo 140). The operational value of the pumps in the fire-damaged stations was rendered negli-

e. Of the 14 frame structures erected to house the pumping equipment, five were damaged by fires (Photos 137, 139, and 140) and 9 were damaged by blast (Photos 141, 146, 147, 148, and 149). Table 35 gives the extent of damage to all pump station buildings. The wood-frame type structures constructed for the pumping stations were typical Japanese construction and could be readily replaced if damaged.

PHOTO 140-XIII. Fire damage to Sewer Pumping Station 9, situated 1,900 feet from GZ.

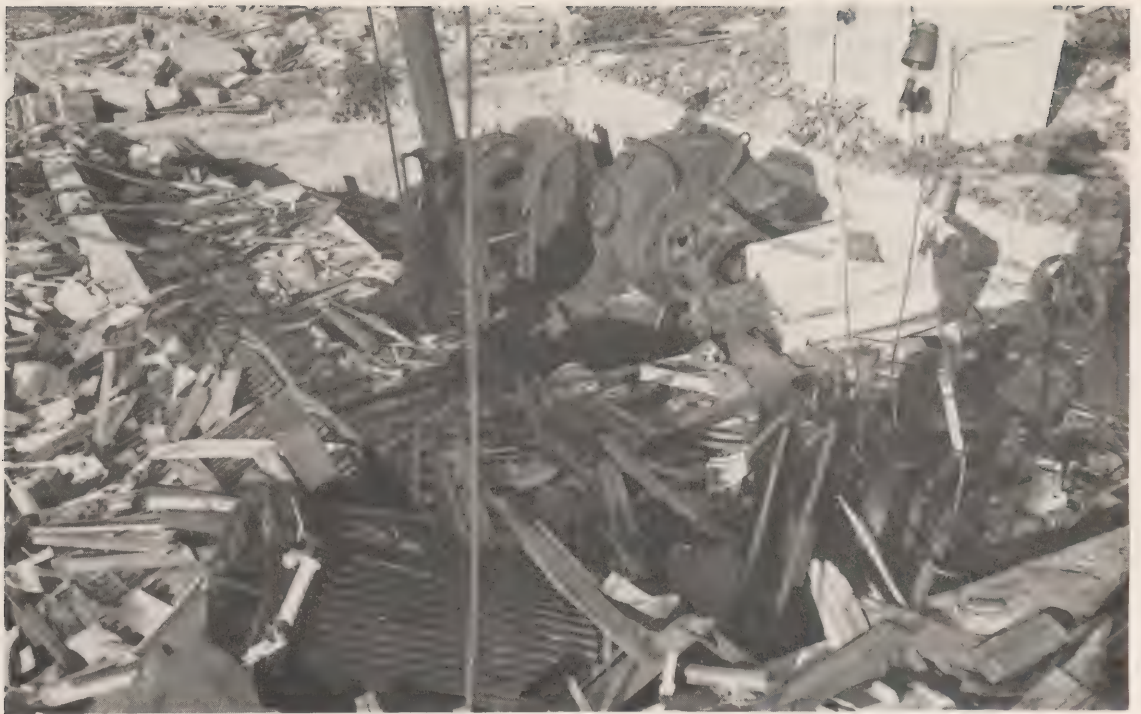
gible because of burned packing, fused bearings, and distorted shafting. As expressed above, the greatest damage incurred was by the fires as an indirect effect of the atomic-bomb explosion. With the exception of Station 11 (Photo 141) in which the electric panel and transformers were severely damaged by blast, all other stations suffered relatively light blast damage (Photos 142, 143, and 144), except stations 1 (Photo 135) and 5 which were previously discussed. Station 11 (Photo 141), although in a fire area, was an isolated case, being in a sparsely settled district.

PHOTO 141-XIII. Blast damage to Sewer Pumping Station 11, located 3,100 feet from GZ.

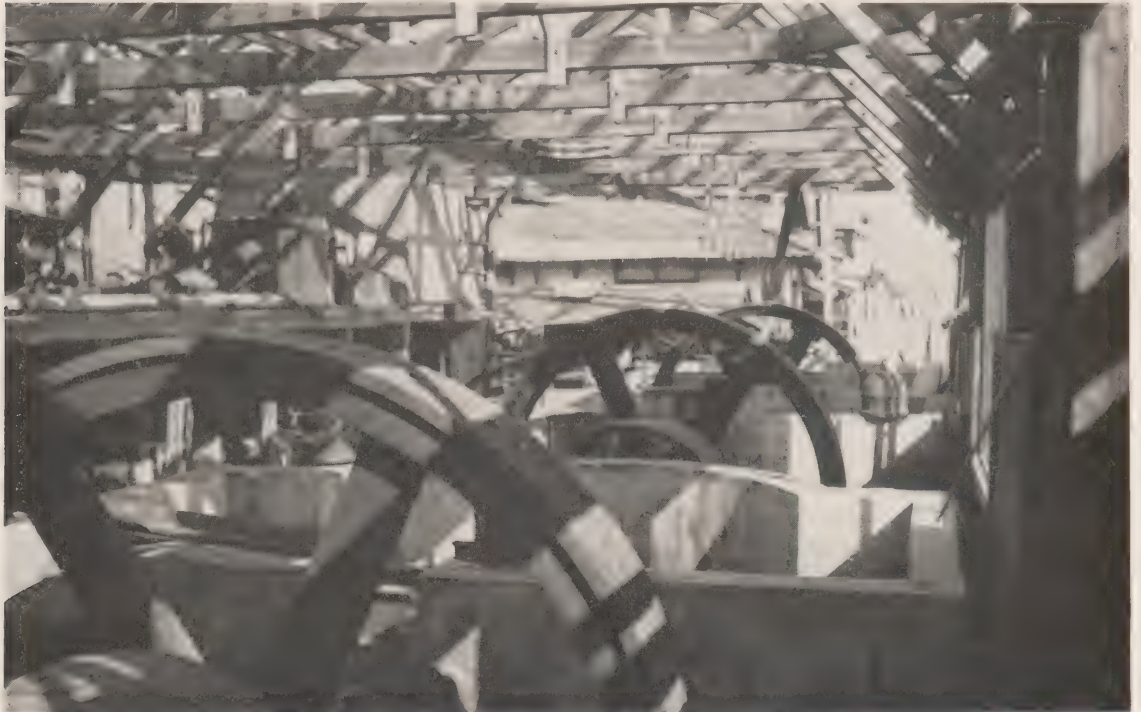
PHOTO 142-XIII. Blast damage to Sewer Pumping Station 8, located 6,900 feet from GZ.

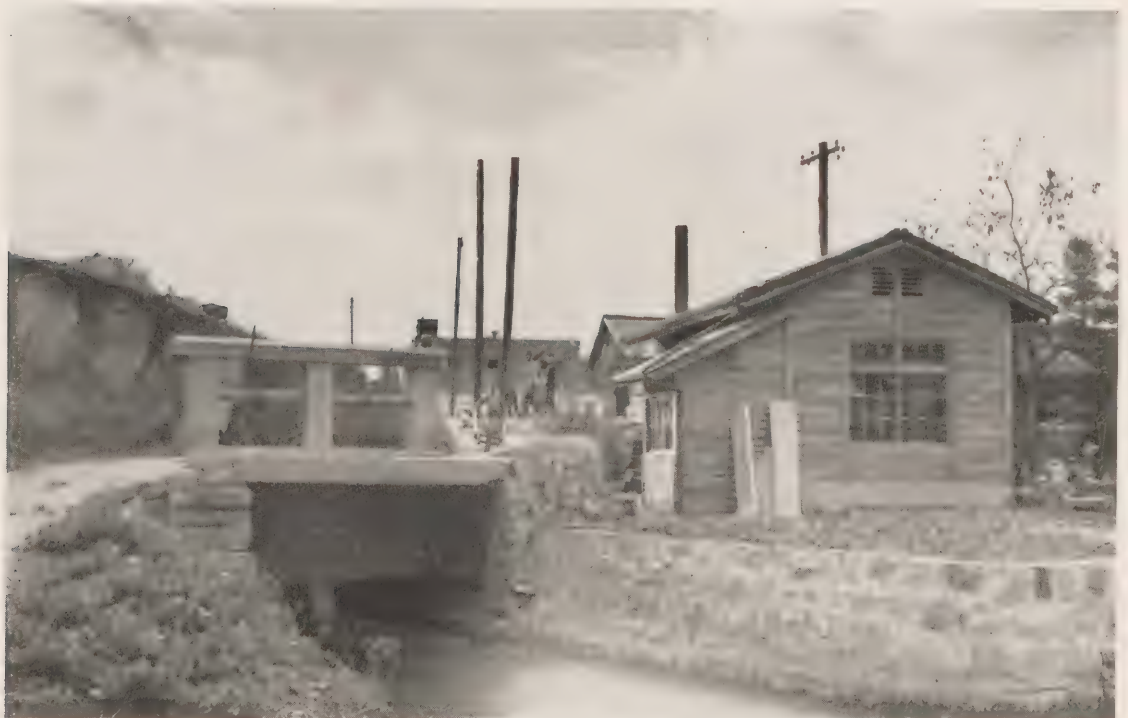
PHOTO 146-XIII. Sewer Pumping Station 1 showing minor blast damage.

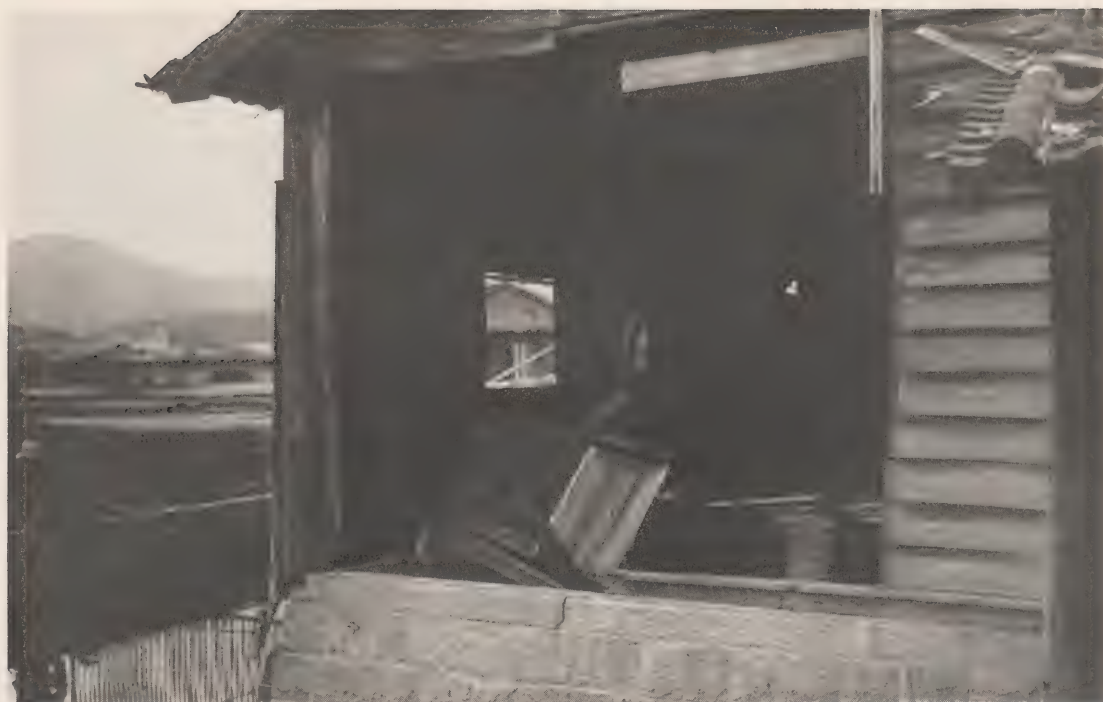
PHOTO 147-XIII. Blast damage to Sewer Pumping Station 3, located 14,000 feet from GZ.

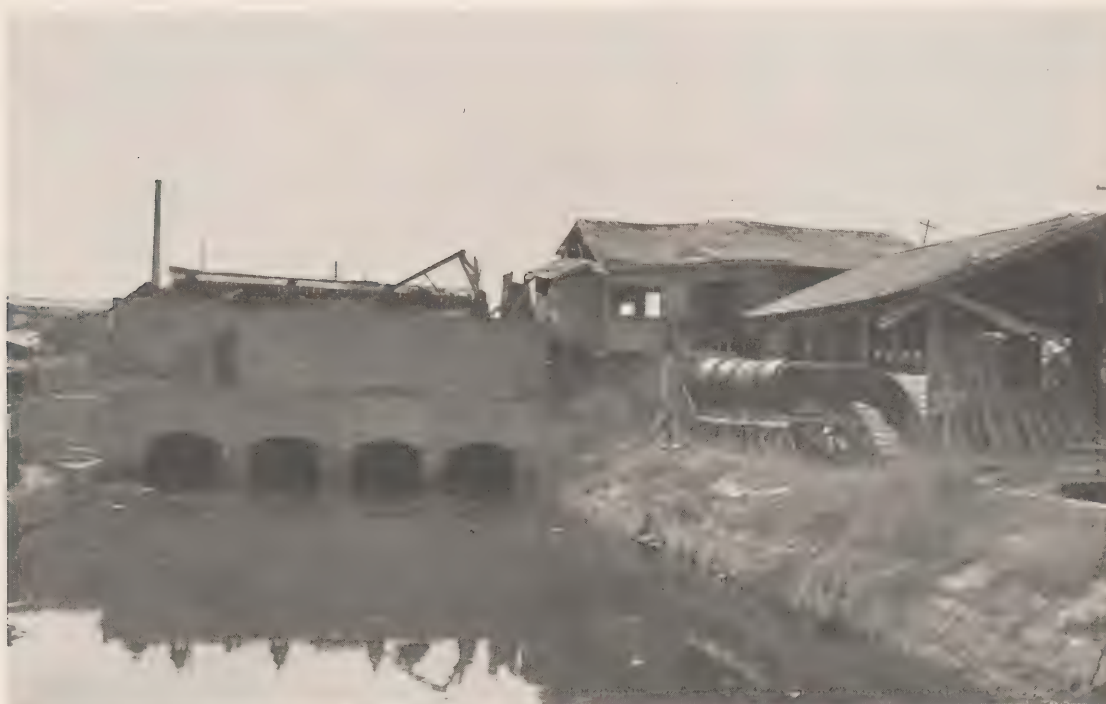
PHOTO 148-XIII. Blast damage to Sewer Pumping Station 12, located 11,600 feet from GZ.

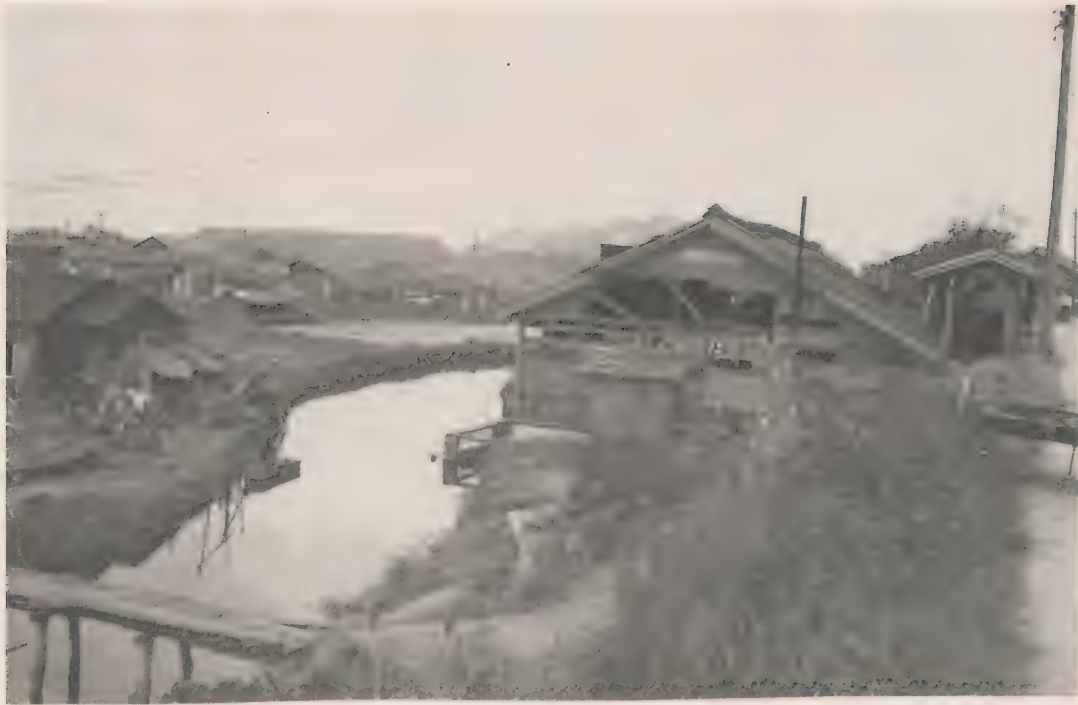
PHOTO 149-XIII. Blast damage to Sewer Pumping Station 4, located 11,100 feet from GZ.

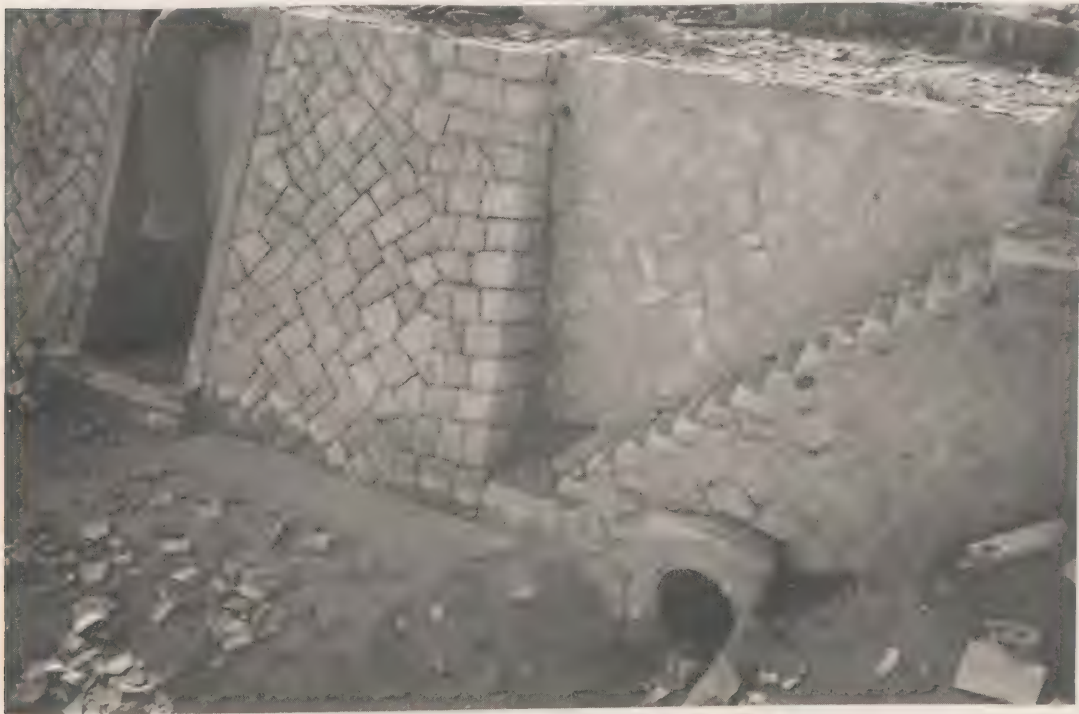
f. There was no evidence of direct bomb damage to sewer mains (Photo 150), although the nearest reinforced-concrete-box main, 4.5 feet by 3.3 feet with a 3-foot earth cover, was only 2,100 feet from GZ. The city engineer stated that up to 15 November 1945 no breaks had been discovered. The open flumes (Photo 151) and ditches (Photo 152) were not damaged but were in some instances partly filled with mud and rubble. Of all the manholes observed not one was overflowing, a condition which would have indicated the presence of broken or crushed mains.

PHOTO 150-XIII. Pump outlet and gravity flow outlet at Sewer Pumping Station 6, located 5,000 feet from GZ.

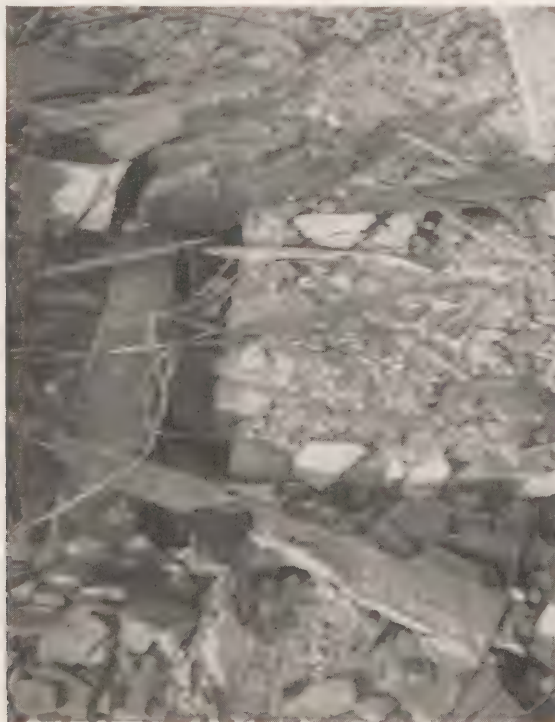
PHOTO 152-XIII. Rubble-and-debris-filled concrete drainage ditch, 1,200 feet from GZ.

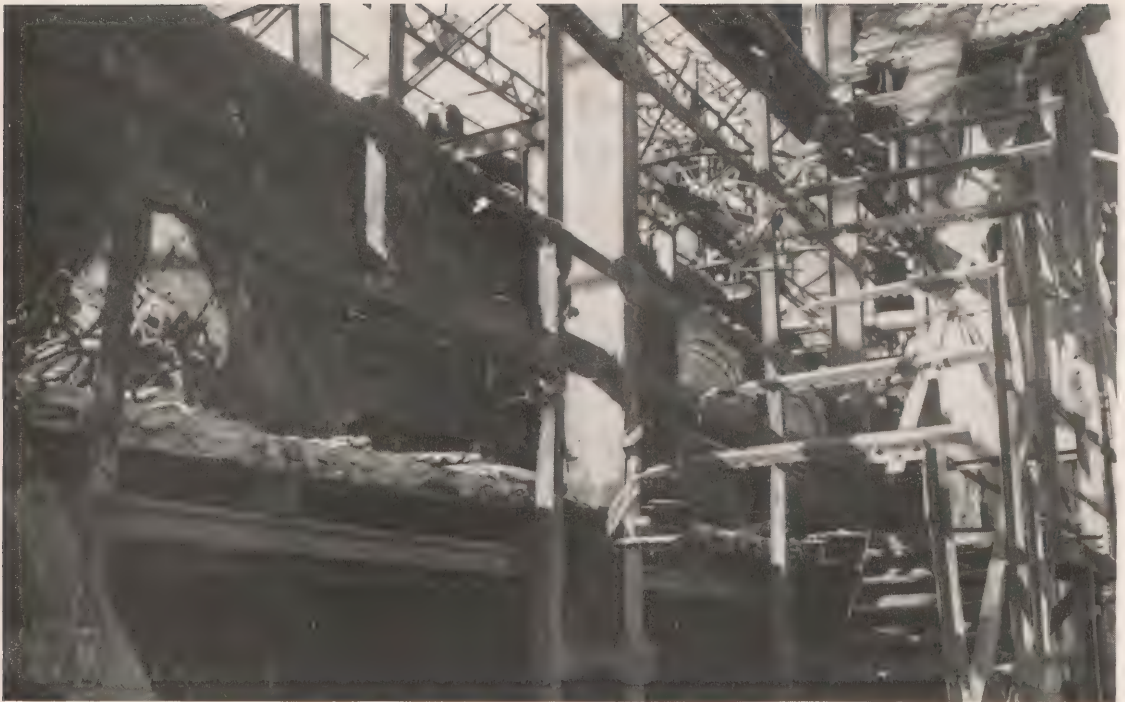
a. At the time of the atomic-bomb attack of 6 August 1945, the domestic gas plant of the Hiroshima Gas Co., at a distance of 6,700 feet from GZ, was producing at its maximum capacity. Initial damage by blast to operating equipment was slight (Photo 153). The electrical distribution panel in the pumping station received heavy damage to the wiring and meters (Photo 154). The station recording meters were also heavily damaged. Replacements of parts were necessary to

PHOTO 153-XIII. Damage by blast to coking ovens at the Domestic Gas Plant, 6,700 feet from GZ.

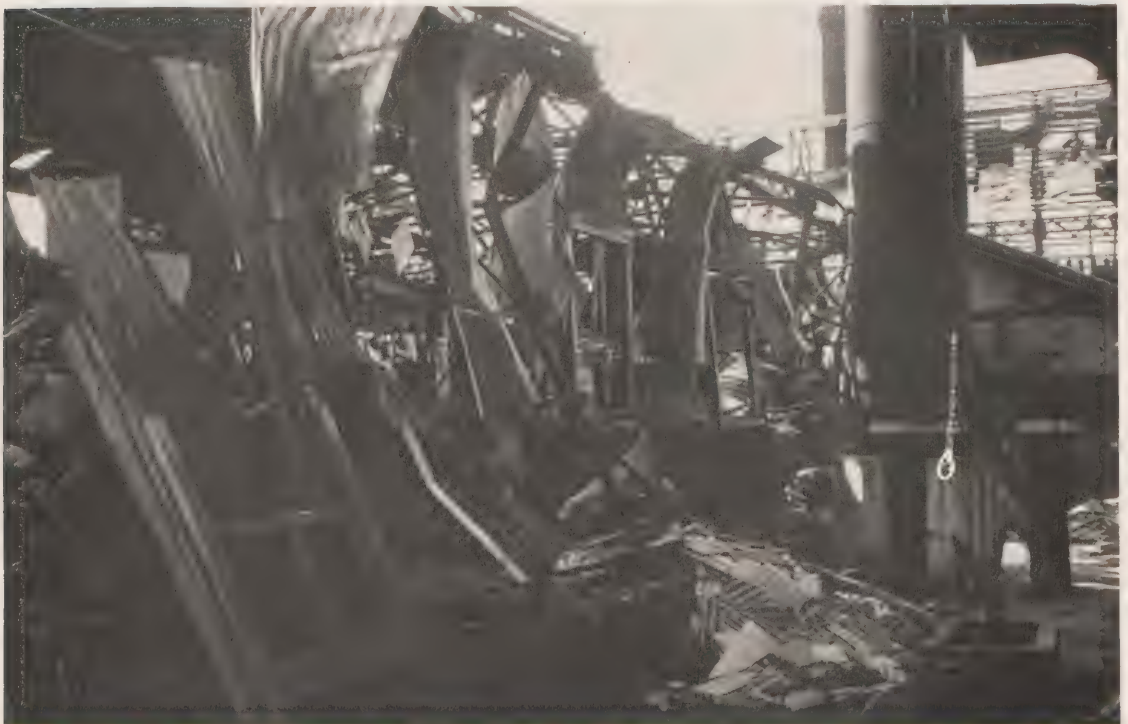
PHOTO 154-XIII. Damage to electrical switchboard panel in Building 112, 6,700 feet from GZ.

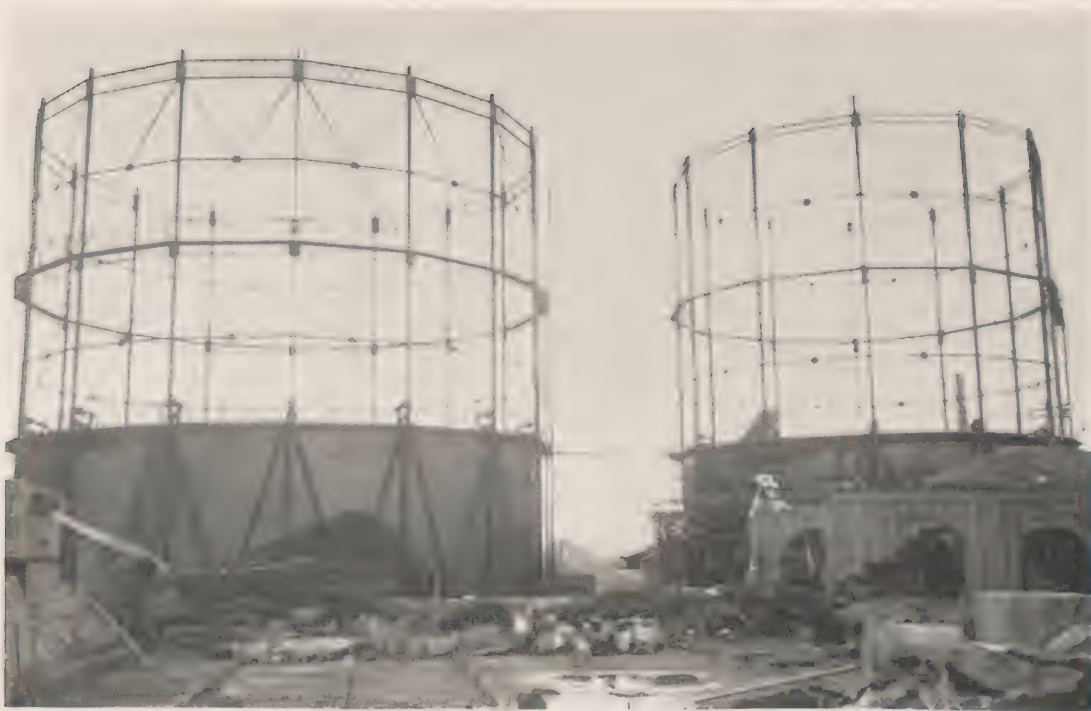
make this equipment operative. The gas holders, however, were more severely damaged (Photo 155). The holder crowns were depressed by the blast (Photo 156) and the downward vertical movement of the lifts compressed the gas sufficiently to build a pressure that tore the already weakened riveted joints when the pressure from the blast front was released, which allowed the gas to escape. There was an immediate ignition but no explosion, and all the escaping gas was consumed by fire. Since no gas pressure remained to hold the two lifts of each holder above the water elevations of the water receptacles, both lifts of each holder dropped to the floor elevation of the water receptacle. Framing members, however, were undamaged. All operations in the production plant stopped immediately. Three hours subsequent to the blast, fires were started in the plant area, having been driven to the vicinity by a south wind. Because of the immediate drop in water pressure and the lack of electricity to operate the auxiliary water pumps, no effort could be made to extinguish the fires. The Sendamachi electric substation in this area was damaged and electric power was interrupted. No additional damage to the equipment by fire was noted.

PHOTO 155-XIII. Fire and blast damage to gas holders and buildings, 6,500 feet from GZ.

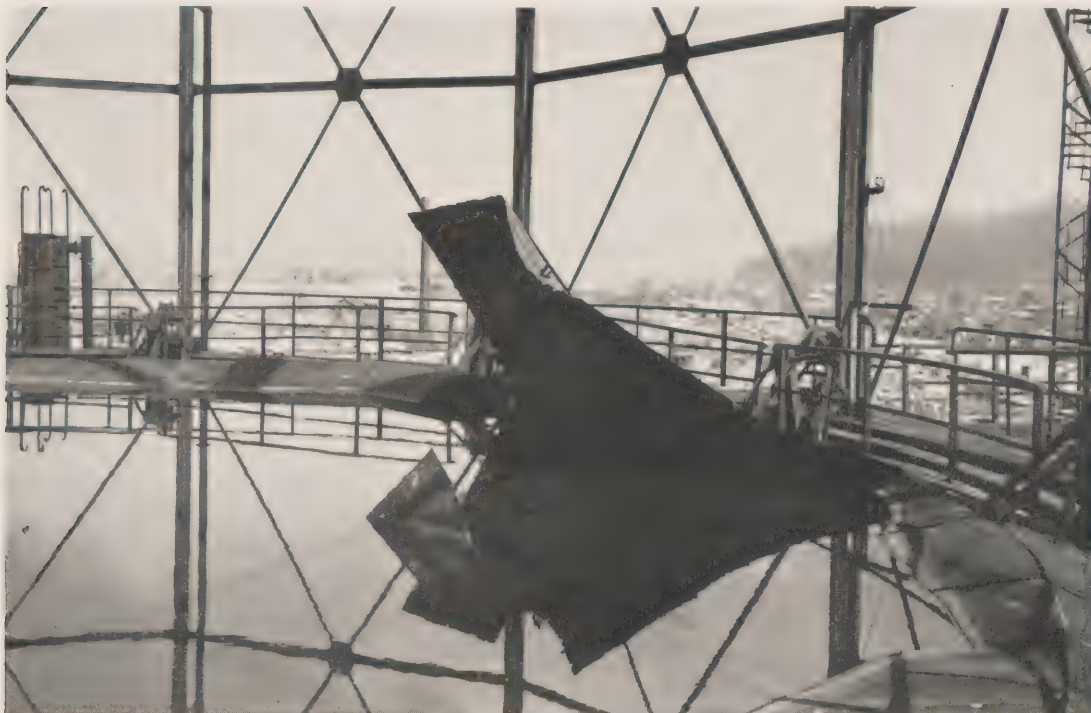
PHOTO 156-XIII. Crown of holder depressed by blast and section raised by compressed gas, 6,500 feet from GZ.

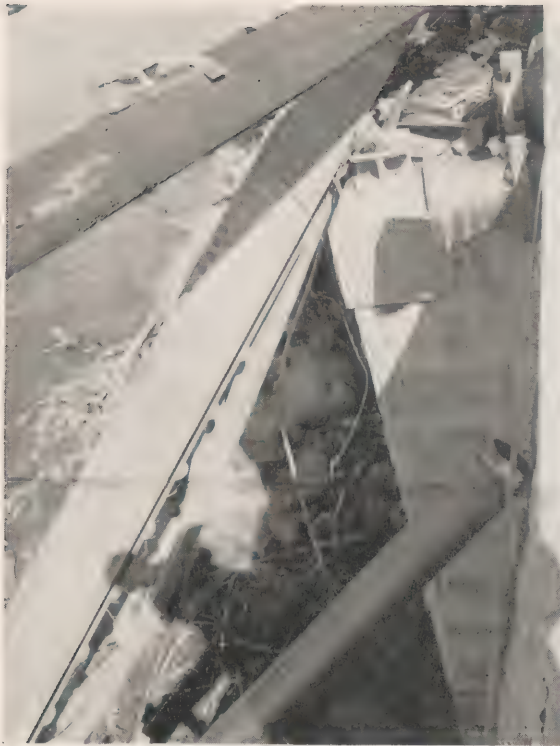
PHOTO 159-XIII. Broken gas main at Bridge 29. Over-crossing structurally damaged by blast, 1,200 feet from GZ.

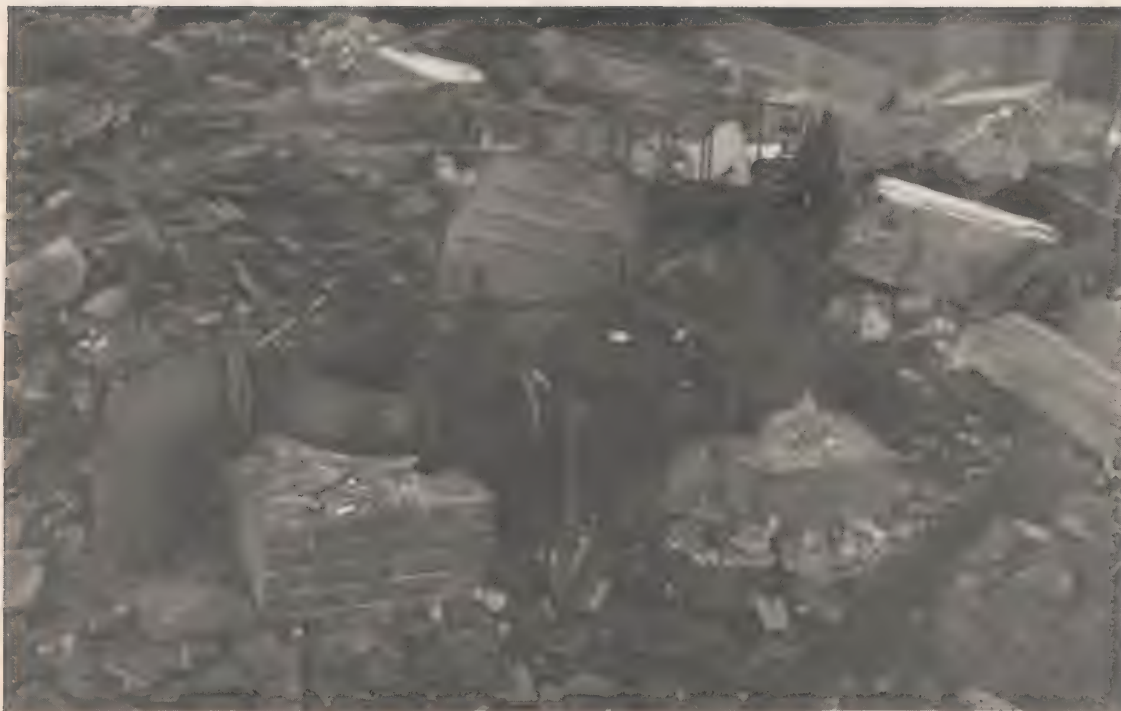
The greatest damage to Regulators 1 (Photo 163) and 2 (Photo 164) was distortion to the balancing mechanism and freezing of the valves by fire.

Only a small amount of damage was incurred by blast and that was by flying debris. Both regulators, however, were rendered useless. No damage was visible to Regulators 3 and 4 and no breaks or damages to piping was noted at these points of exit.

PHOTO 163-XIII. Pressure Regulator 1 damaged by debris and fire, 800 feet from GZ.

d. Pressure regulators converted high pressure to low pressure for consumer distribution. The damage received by regulator 2 at 1,700 feet from GZ did not confine the limit of effective damage solely to its area for these reasons: (1) Damage was such that no gas could flow and the area was cut off in proportion to the distance to the next regulator, depending on a loop system being in the area, or (2) the pressure in the high- and low-pressure systems was equalized, creating a dangerous situation for consumers. In order to protect the regulators against damage from similar attacks a good solution would be to install them in reinforced-concrete manholes constructed below ground elevation.

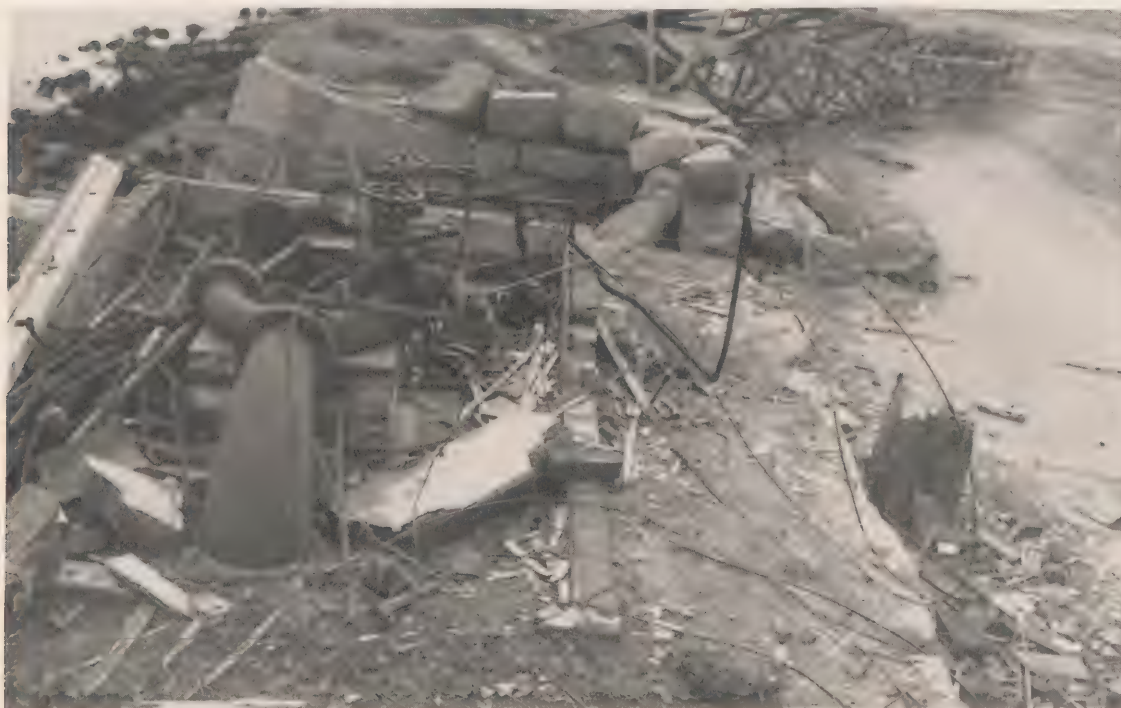
PHOTO 164-XIII. Pressure Regulator 2 damaged by debris and fire, 1,800 feet from GZ.

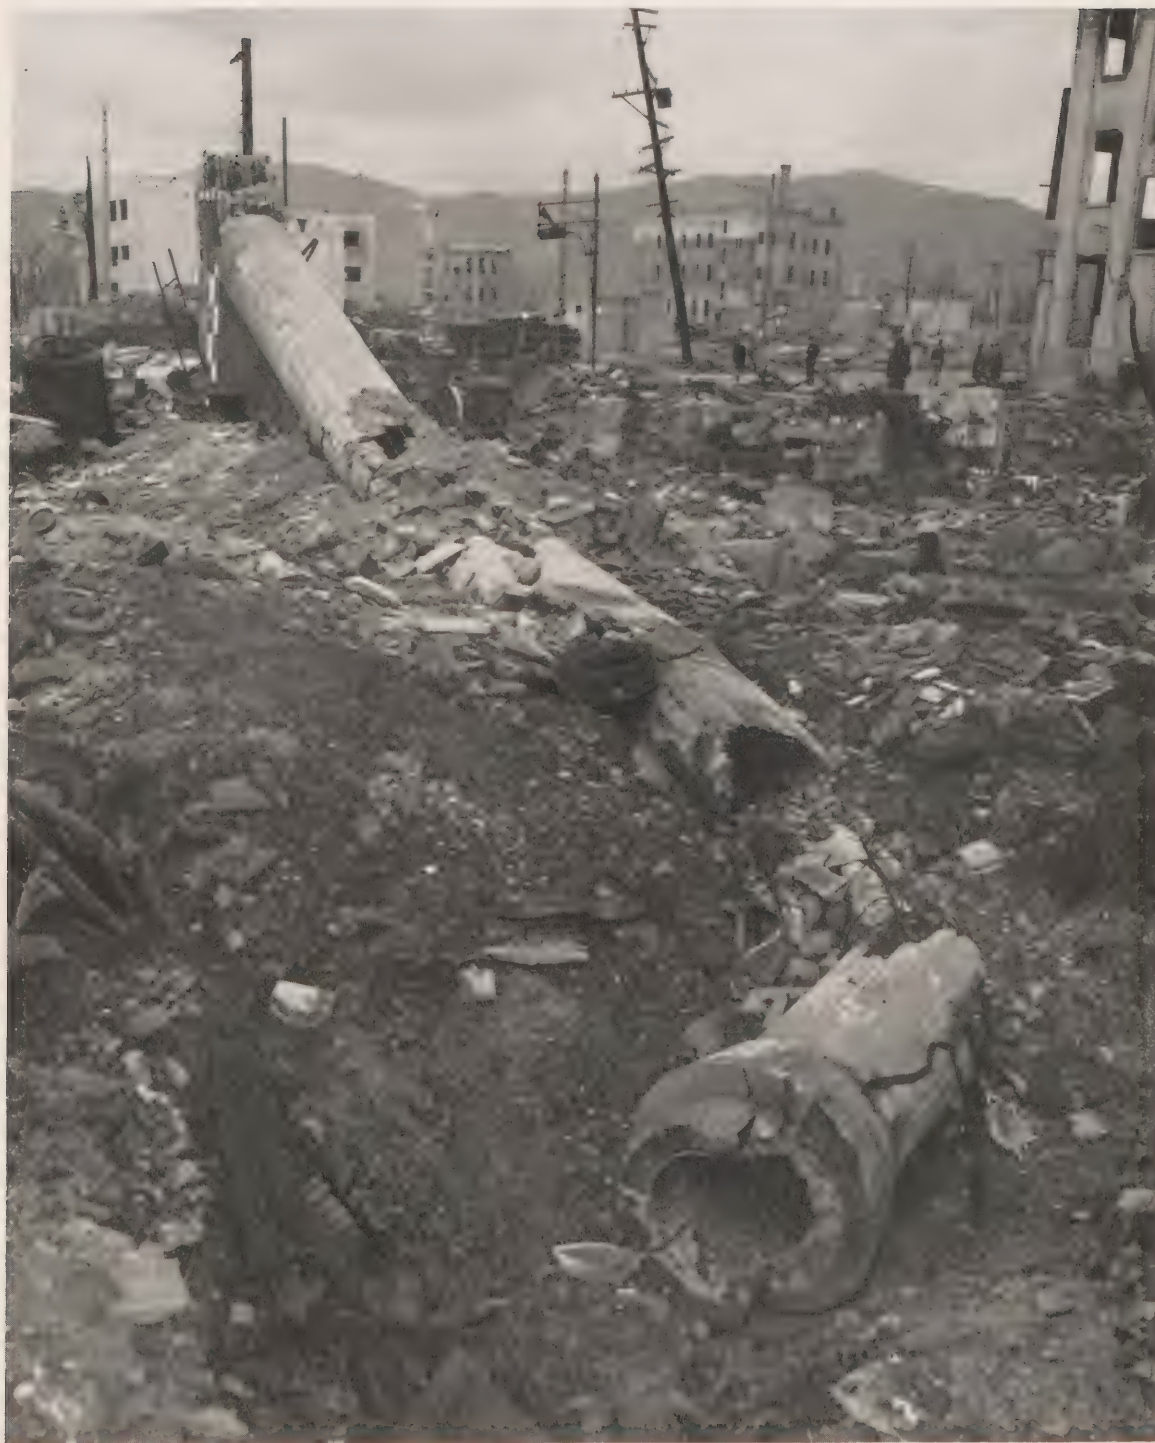
PHOTO 5-XIV. Stack 3. Reinforced concrete, 1,100 feet from GZ.

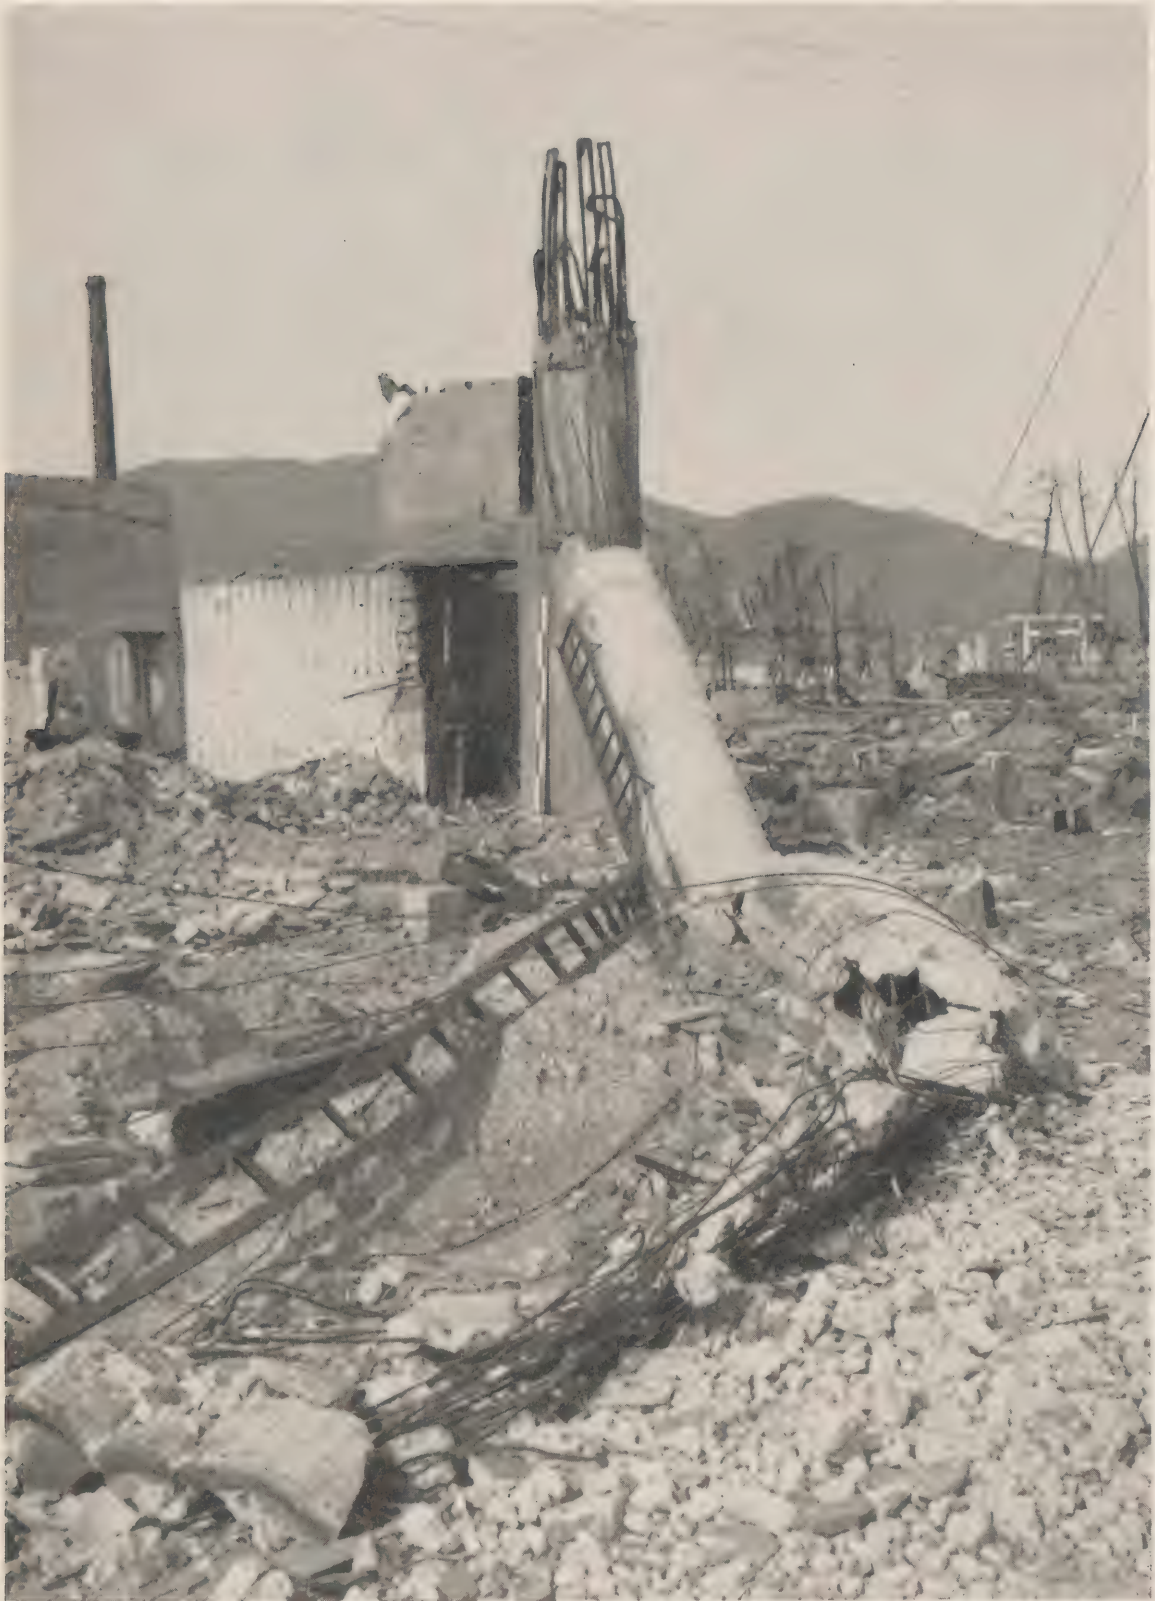
PHOTO 6-XIV. Stack 14. Reinforced concrete, 2,400 feet from GZ, with $1\frac{1}{2}$ -inch heating pipes protruding from base.

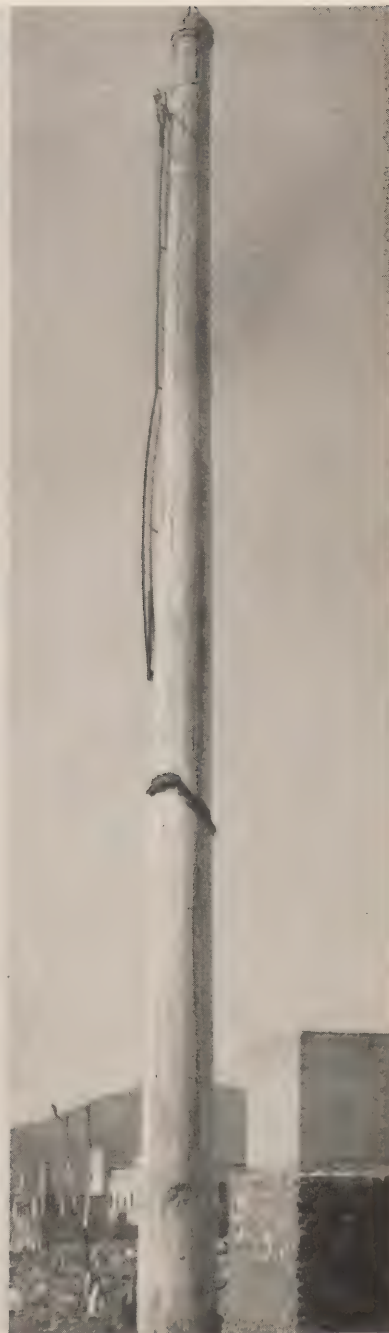
PHOTO 8-XIV. Stack 48. General view of stack shown on Photo 7.

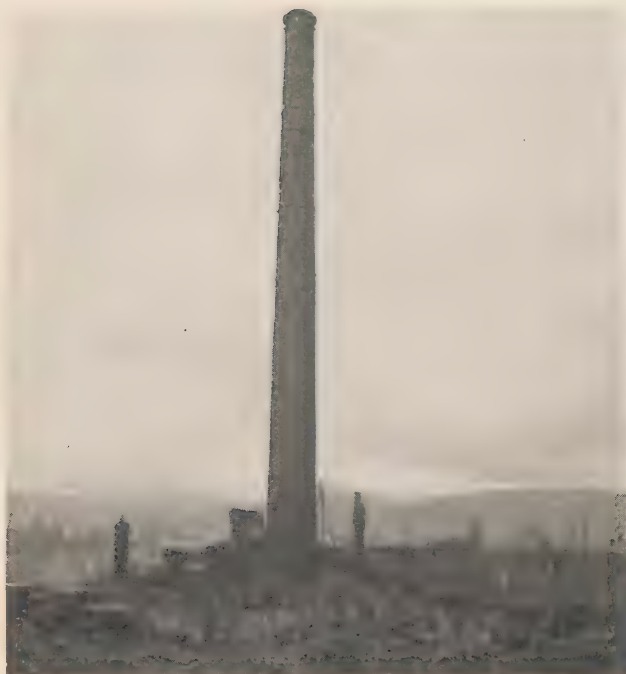
PHOTO 9-XIV. Stack 27. Reinforced concrete 6,800 feet from GZ.

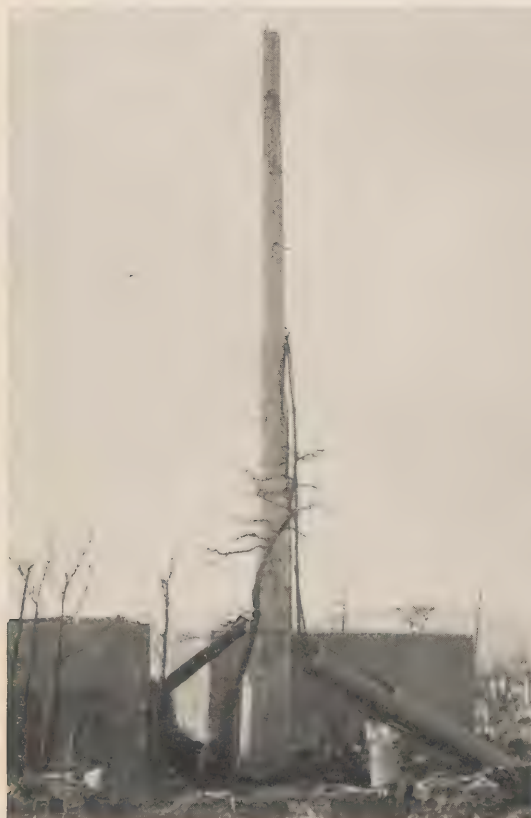
PHOTO 10-XIV. Stack 54. Reinforced concrete, 4,000 feet from GZ. Sheared off at 55 feet.

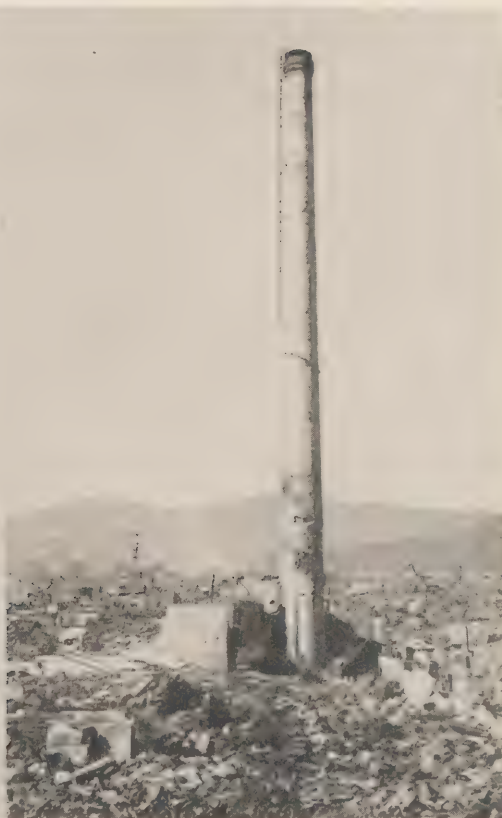
PHOTO 11-XIV. Stack 12. Reinforced concrete, 1,900 feet from GZ. Fractured at 16 feet

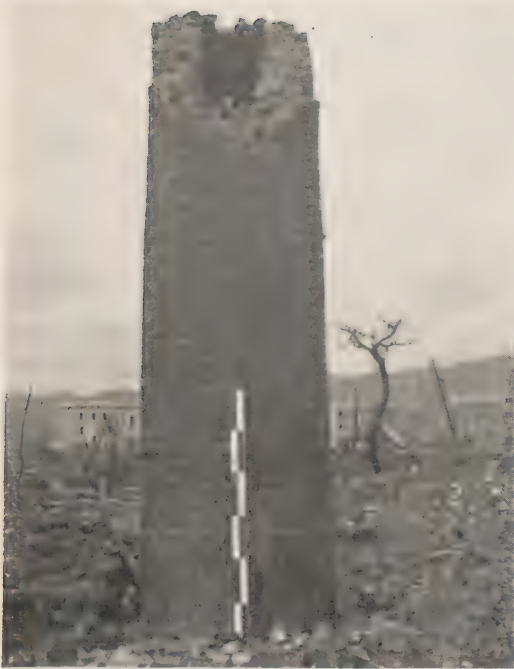
PHOTO 13-XIV. Stack 4. Hexagonal brick, 1,700 feet from GZ. Sheared off at 12 feet.

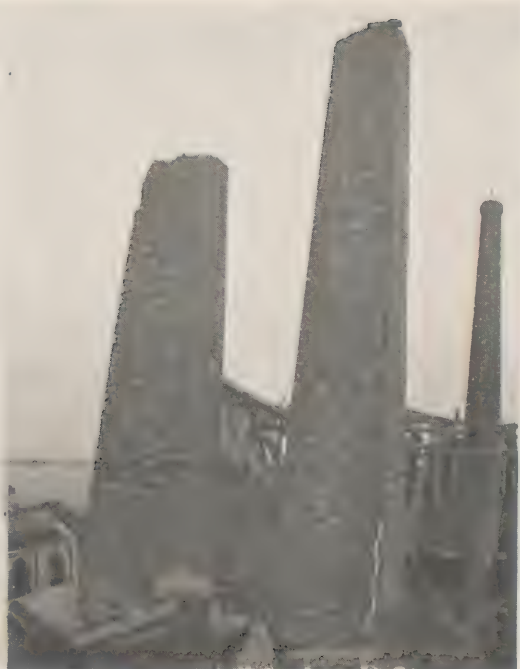
PHOTO 14-XIV. Stacks 19 and 20. Square, brick, 4,200 feet from GZ. Sheared off at 35 feet.

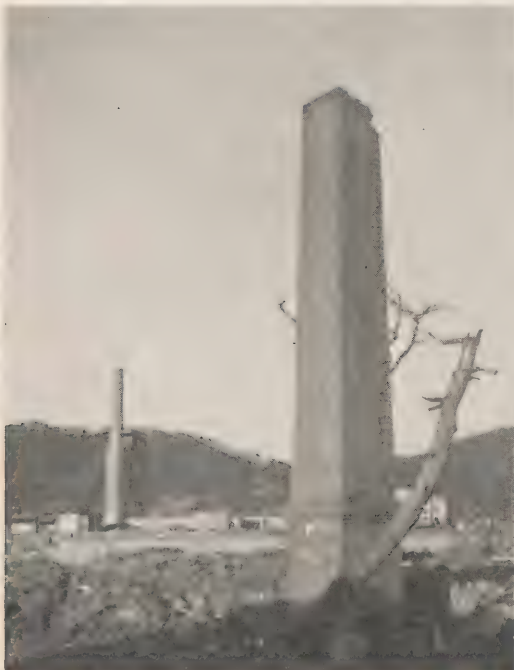
PHOTO 5-XIV. Stack 30. Square, brick, 5,000 feet from GZ. Sheared off at 35 feet.

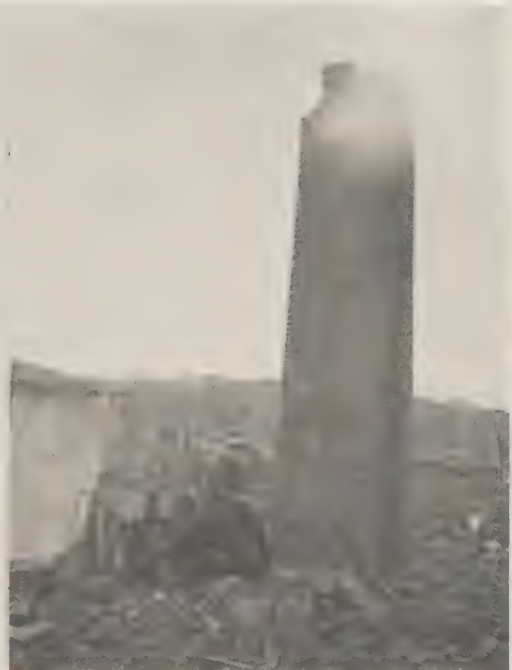
PHOTO 16-XIV. Stack 32. Square, brick, 4,000 feet from GZ. Sheared off at 20 feet.

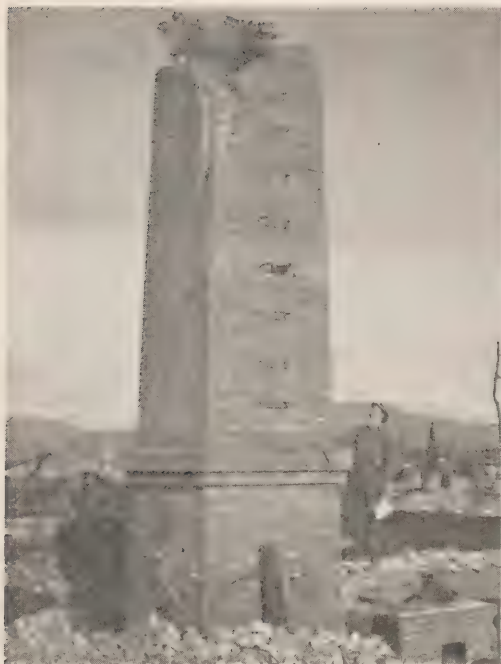
PHOTO 17-XIV. Stack 37. Square, brick, 8,100 feet from GZ. Sheared off at 20 feet.

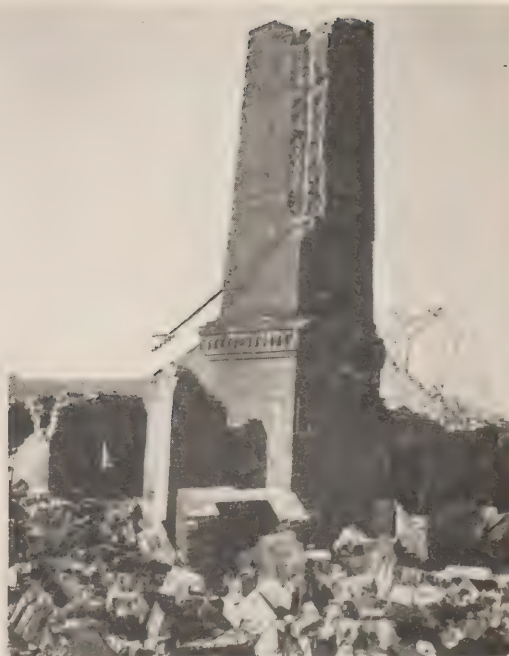
PHOTO 18-XIV. Stack 50. Square, brick, 2,400 feet from GZ. Sheared off at 30 feet.

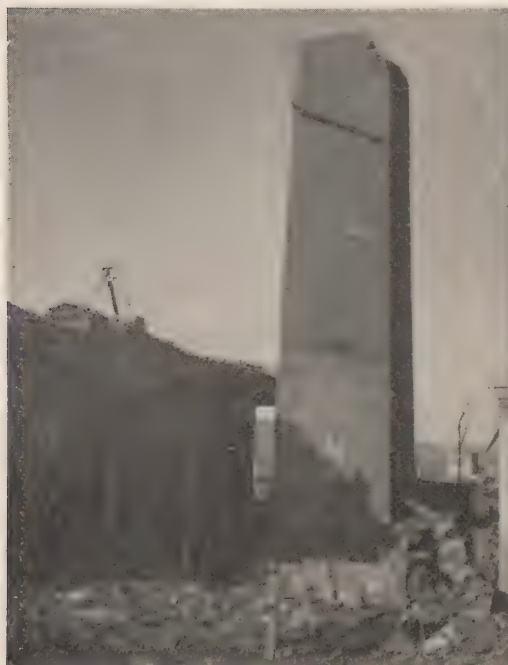
PHOTO 19-XIV. Stack 25. Square, brick, 3,800 feet from GZ. Sheared off at 30 feet.

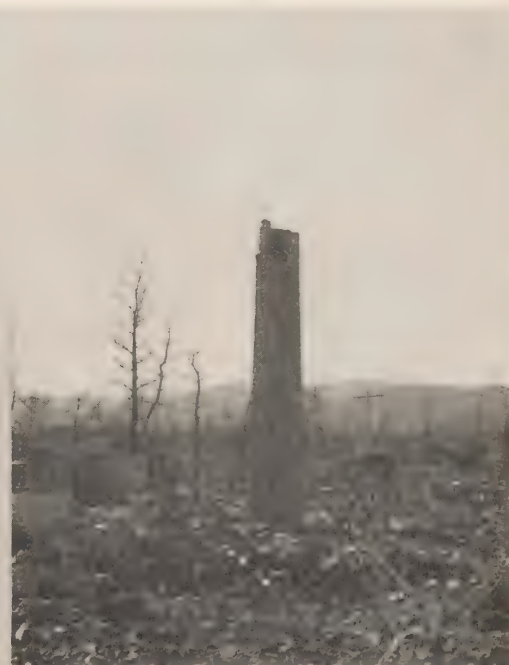
PHOTO 20-XIV. Stack 60. Square, brick, 6,300 feet from GZ. Sheared off at 30 feet.

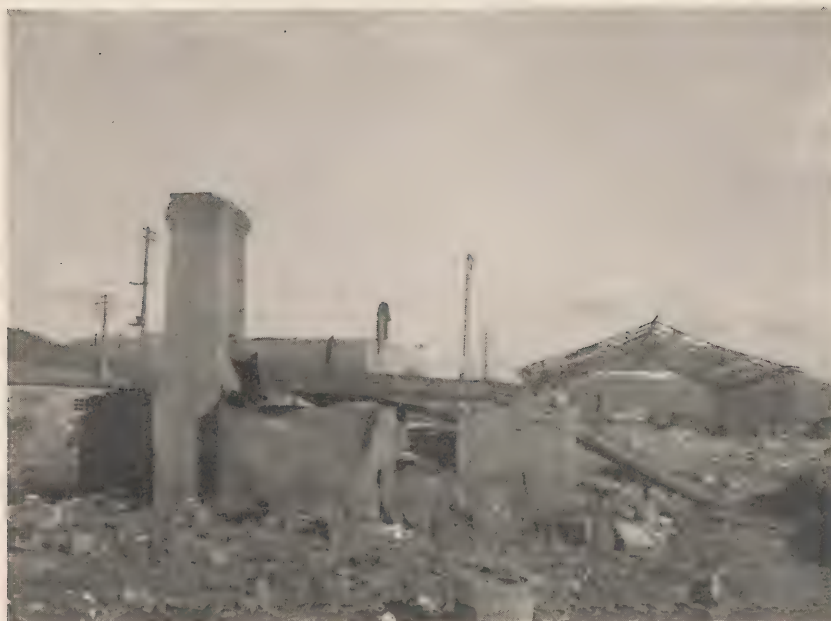
PHOTO 21-XIV. Stack 62. Steel with brick base, 5,200 feet from GZ.
Failed at anchorage to base.
